Manhole Inspection Summary

Manhole # S09QQ1034MH

Insp Date: **1/21/09 12:57 PM**

Location Address: **3000 SPAULDING AVE**

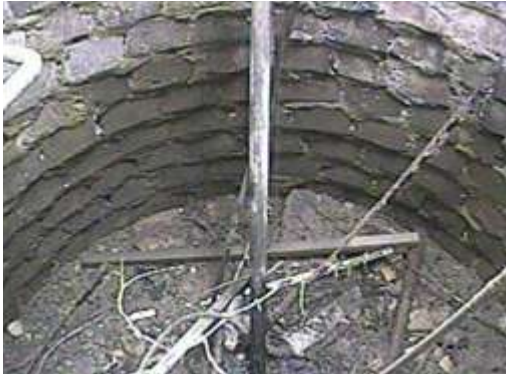
Defect 1

Condition: ☐ Sound ☐ Cracked ☐ Root Intrusion ☐ Deteriorated ☐ Leaks ☒ **Debris**

DEBRIS

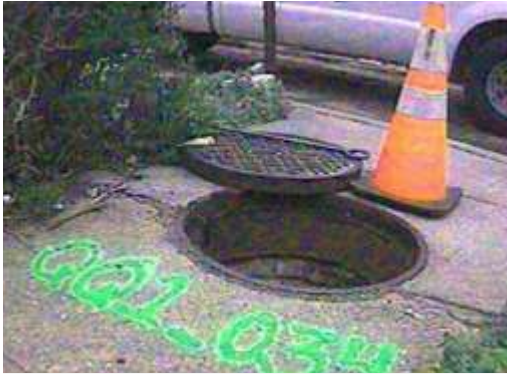
Defect 3

Offset: **2** (in.)

FRAME OFFSET

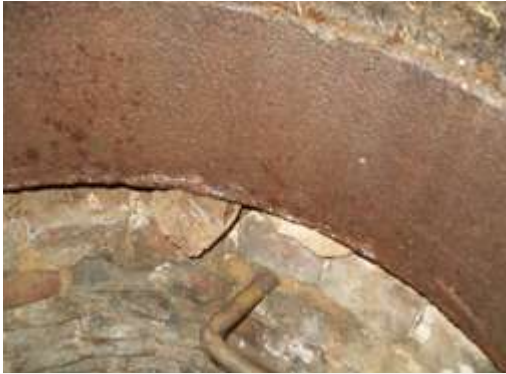
Defect 2

Condition: ☐ Sound ☐ Cracked ☐ Root Intrusion ☒ **Loose Brick** ☐ Deteriorated

LOOSE BRICK

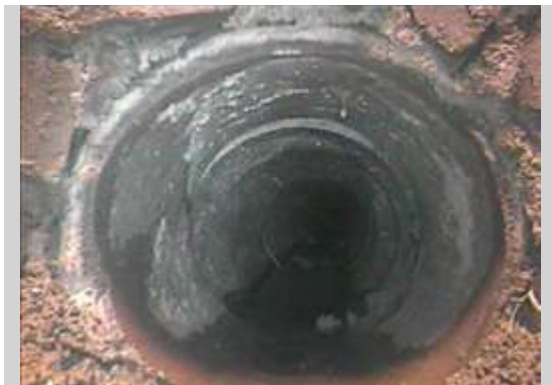
12 O'Clock Outflow

8 in. Circular Gravity Sewer
Pipe Out @ 12 O'Clock

Pipe Material: **Clay** ☐ Pipe Lined

Invert Depth: **6.05** (ft.) Flow Characteristics: **None**

Deposits: ☒ None ☐ Mud ☐ Sludge ☐ Debris ☐ Grease

Infiltration: **None** Pipe Seal Cond: **Sound**
